# AAR - MAN LAN Core Node Hardware Upgrade ...

## After Action Report

**Network:** MAN LAN

**Issue Name:** Core Node Hardware Upgrade

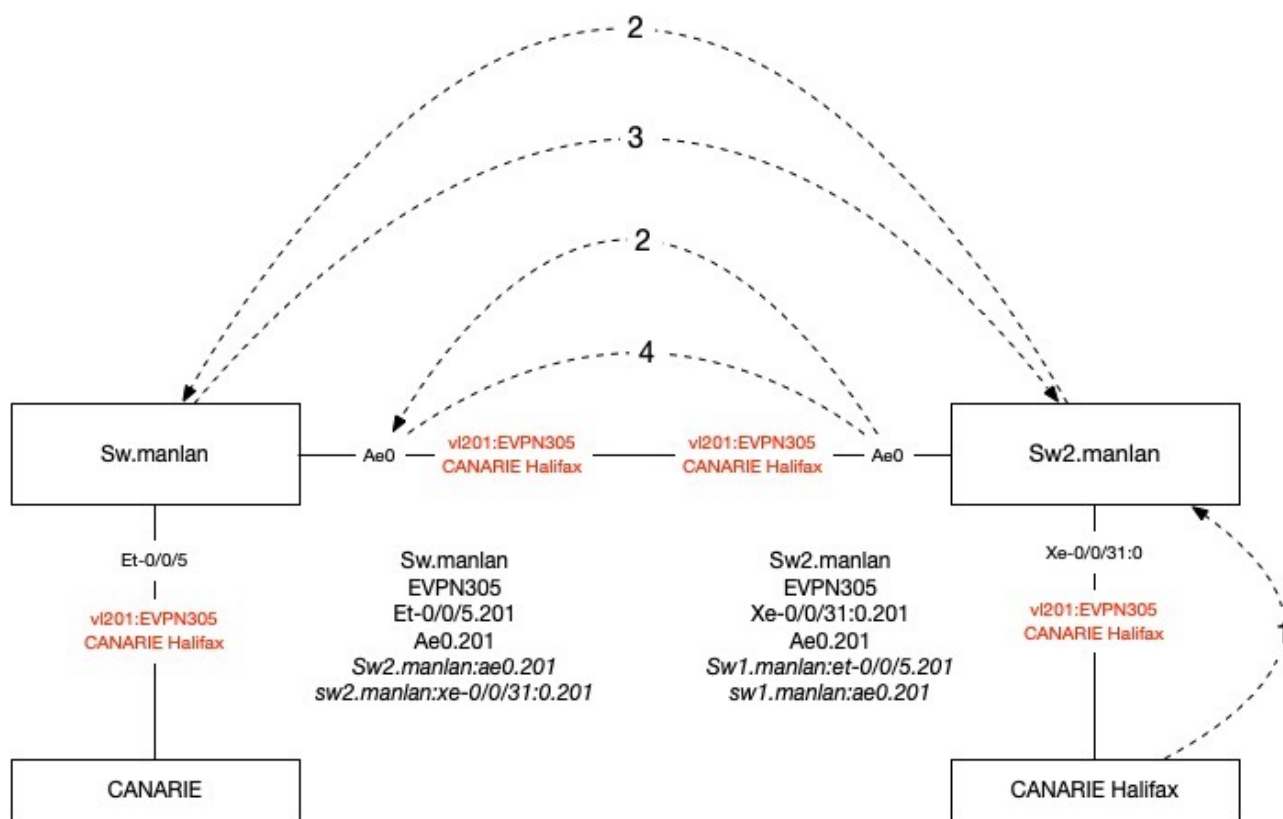
At 1014, engineering re-enabled the ISIS connection between sw.manlan and sw2.manlan, to match the original design. however, this effectively created a loop between the VLAN service interfaces. This is substantiated by time reported by CANARIE indicating performance issues at approximately 10:14AM EDT, 4 minutes after ISIS was enabled. The example below shows what likely occurred in the CANARIE case, however it's understood that this would have been an issue with any network that had ethernet services that spanned the two MAN LAN QFX10002 switches.

- 1.) Broadcast/Unknown Unicast/Multicast (BUM) traffic sent from CANARIE Halifax to sw2.manlan
- 2.) sw2.manlan sends traffic out all local ethernet segments as well as remote peers (sw.manlan) via VXLAN
- 3.) sw.manlan receives traffic via ae0.201 and replicates traffic out all ethernet segments except for ae0.201 (split horizon) but does send it back to the remote peer on sw2.manlan via VXLAN.

sw.manlan also receives traffic via VXLAN and replicates it back via ae0.201 to sw2.manlan.

4.) sw2.manlan receives traffic via vxlan, as well as ae0.201, loop is complete
